Foot wedged under paver hopper.

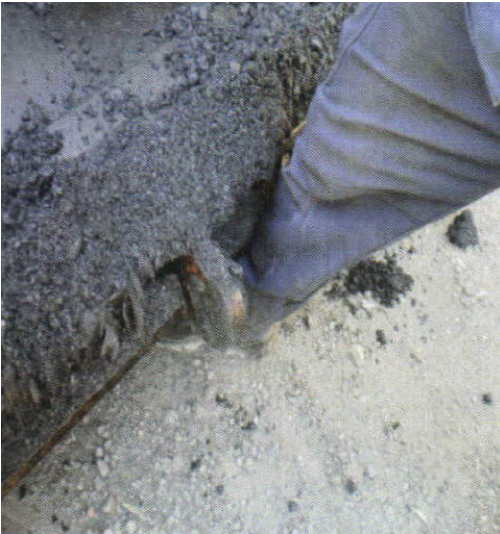
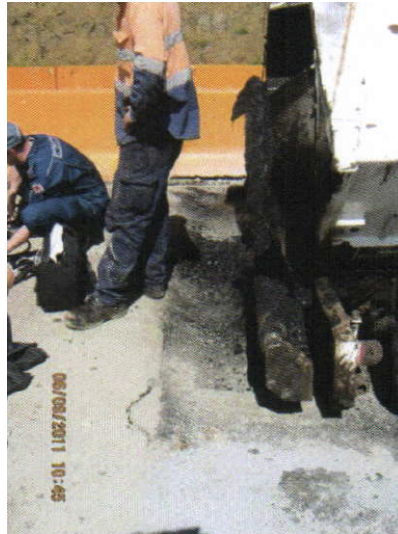
Mid morning in September 2011 on the Warrago Highway, Toowomba Range, Queensland an asphalt crew member was pushing a build up of asphalt from the front of the paver into the paver hopper while the paver was creeping forwards. His right foot became wedged between the ramp at the end of the run and the front of the paver. The resulting injury was a chipped bone and soft tissue injuries to his foot.

The paver was creeping forward at the time of the incident. There were no tippers on site which meant there was no Truck Controller present.

The paver must be stopped (park brake engaged & conveyors turned off) and a Truck Controller or Spotter must be present before any ground personnel work in front of the paver hopper.
