Road roller reverse travel

A road worker was fatally injured when struck by a multi-tired road roller during routine road repair activity.

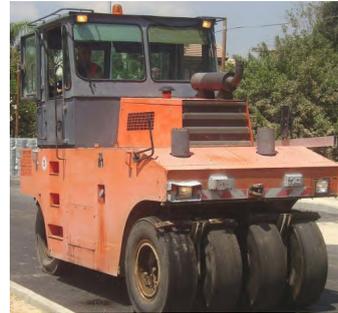
The road roller was travelling in reverse and attempting to pass in close proximity to the worker who was performing a manual task behind another slow moving vehicle

The road roller, without warning, suddenly deviated from the intended direction of travel catching the road worker off-guard. No other workers were injured.

Mobile plant operated too close to workers on foot (insufficient separation distance).

- Inadequate traffic management.
- No spotter used.
- Operator driving visibility restricted.
- Operator error or fatigue.
- Operator training inadequate.
- Operator competency inadequate for operating specific make and model of mobile plant.
- Malfunctioning or defective operational controls.
- Excessive speed.
- Adverse weather conditions.
- Defective audible warning device/s on the plant.

- Areas of worker / plant congestion must be identified and plant movements controlled.
- Ensure plant operators are competent in the operation of the specific make and model of plant, not just the type of plant.

- Implement risk control measures to avoid unauthorised worksite access.
- Reversing travel direction of plant and vehicles should be kept to a minimum.

- Ensure plant and vehicle warning devices are operational and appropriate for the site conditions
- Any changes to plant movement plans must be communicated regularly to all site personnel, visitors and contractors.

- Ensure that operators who perform tasks which subject them to fatigue are changed at regular intervals.
- For road rollers that regularly operate in the reverse direction, where reasonably practicable, ensure that the operator seat (and operating controls) can swivel to face the direction of travel

- When purchasing new plant, ensure that the operator controls allow clear visibility in all directions of travel for which the plant will be used.
- Regularly inspect and test the emergency stopping features of plant.

- When operating procedures are being developed, consideration should be given to ensuring separation distances between workers and mobile plant are clearly defined.
