Contact to person between roller and paver

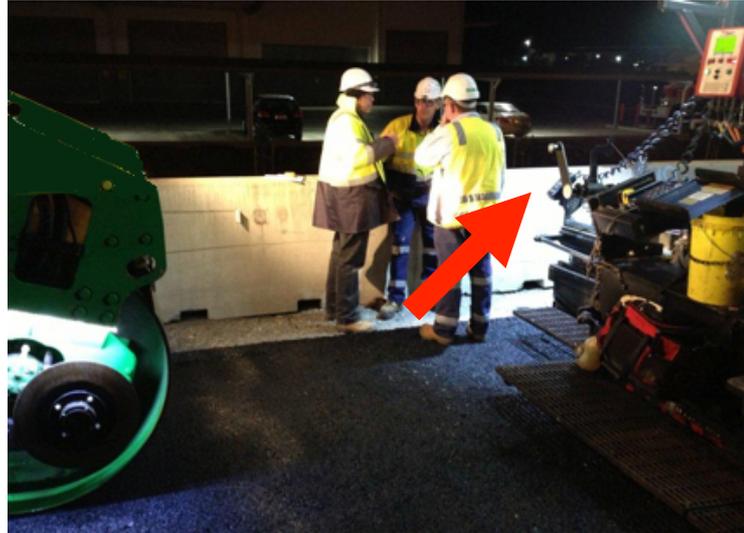
Arrow indicating the location of the paver crank handle into which the roller pressed the contractor

The roller operator then breached the 3 meter exclusion zone. Whilst attempting to put the roller in reverse, it pressed a contractor, standing at the rear of the paver, between the paver crank handle and the front part of the roller. As the paver was still travelling forward, the pressure on the contractor was released almost immediately.

Following a controlled re-enactment of the incident, a mechanical fault was discounted as to being the root cause of the incident. It would appear that the operator panicked as he approached the rear of the paver (inside the exclusion zone) and accidentally placed the lever in the forward position instead of reverse.

The roller brake setting was not set on "hard" which would have significantly decreased the braking distance

1. Operators must be familiar with the equipment they operate – conduct plant specific Verification of Competency to confirm
2. Roller operators should decrease their speed when approaching the rear of the paver
3. The roller brake setting should be on "hard" which significantly decreases the breaking distance
4. SWMS / SOP must prescribe exclusion zones (i.e. 3m behind paver)
5. SWMS / SOP must prescribe the approach speed to plant / people (i.e. approach at 3kph – half normal)
6. Investigate alternate proximity detection / warning devices (i.e. laser light projected from rollers)
7. Pedestrians, persons on foot and contractors should be removed from plant exclusion zones
